Langridge, R.M; Zajac, A; Ries, W. 2010. Fault Avoidance Zone Mapping for Wairoa District, Napier City and surrounds, *GNS Science Consultancy Report 2010/105*. 35 p.

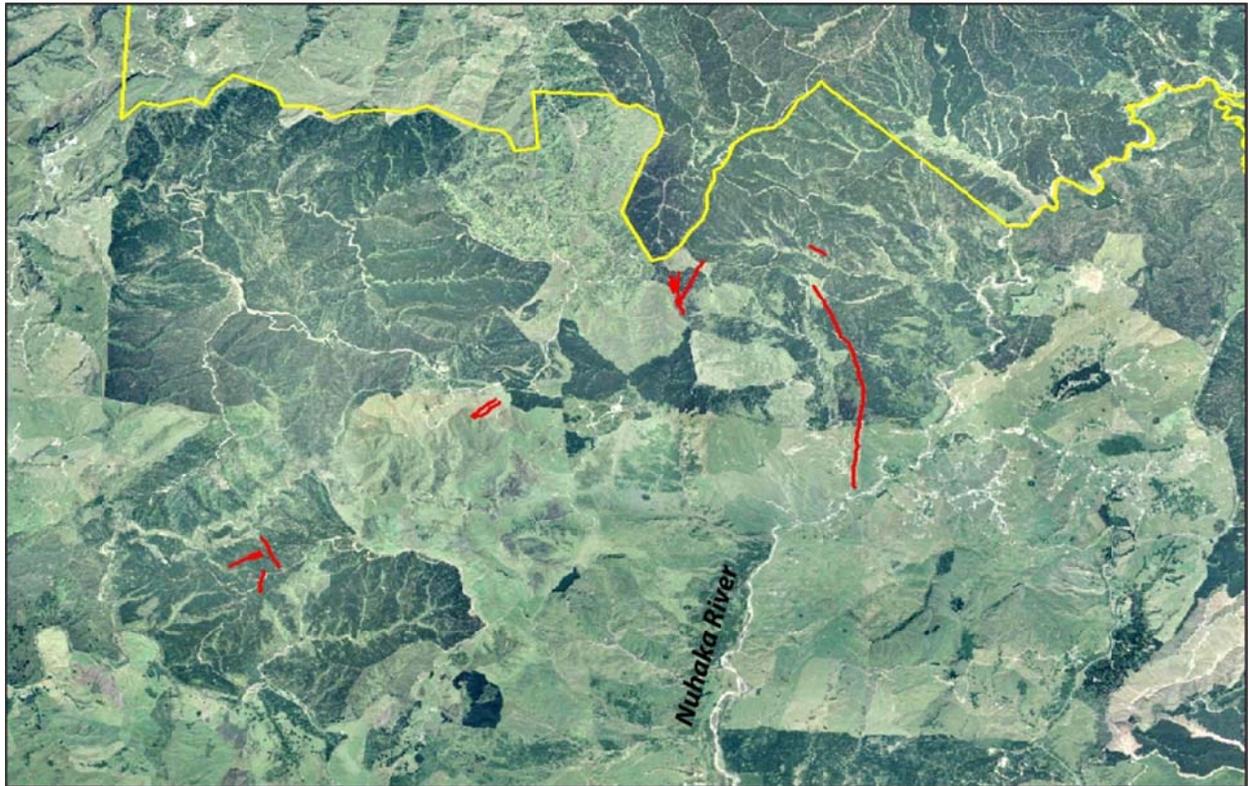
Figure 6 Orthophotograph of part of Wairoa District in the area of the upper Nuhaka River. The yellow line represents the northern boundary of Wairoa District. Red lines represent updated fault linework (possible active fault traces) for this area. The GIS data with Fault Avoidance Zones from the accompanying CD should be used to characterise this line data.

In the Wairoa North area, we relied on aerial photograph analysis as the means for confirming (or refuting) the presence of active faults (Fig. 6). Following a re-analysis of this area, a large number of traces were not considered to represent active fault traces. In many
